**Re: Report of Findings – Phase I Environmental Site Assessment  
1050 Markham Road  
Toronto, Ontario  
Project No. 18055D**

**REPORT OF FINDINGS**  
**PHASE I ENVIRONMENTAL SITE ASSESSMENT**

1050 Markham Road  
Toronto, Ontario

Prepared For: CAPREIT Limited Partnership  
Project No: 18055D  
May 2023

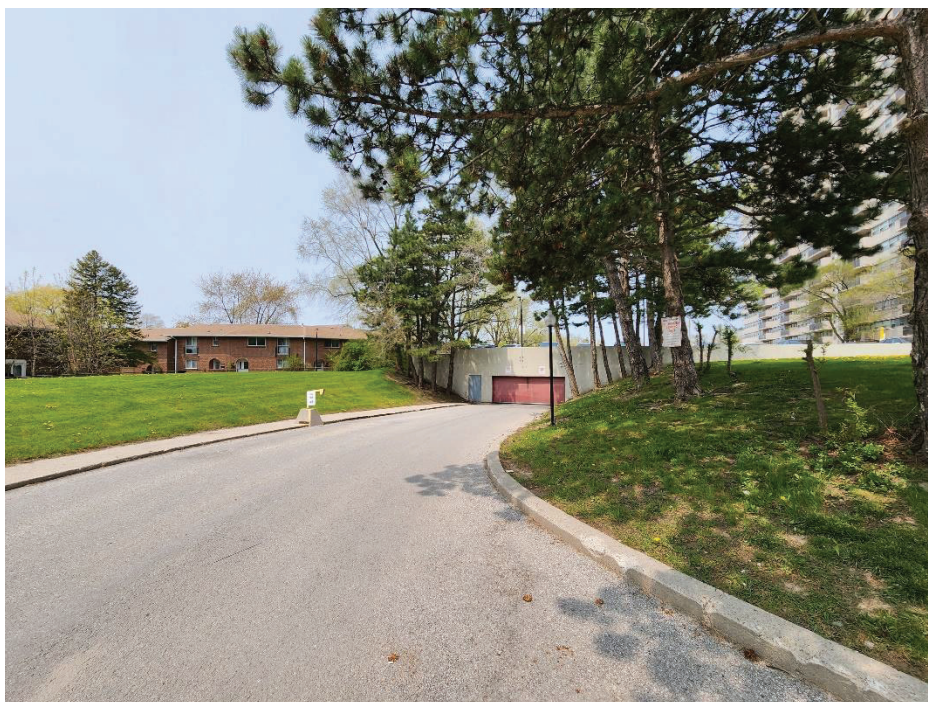
**Photograph 3:** View of ramp to underground parking garage in southwest corner

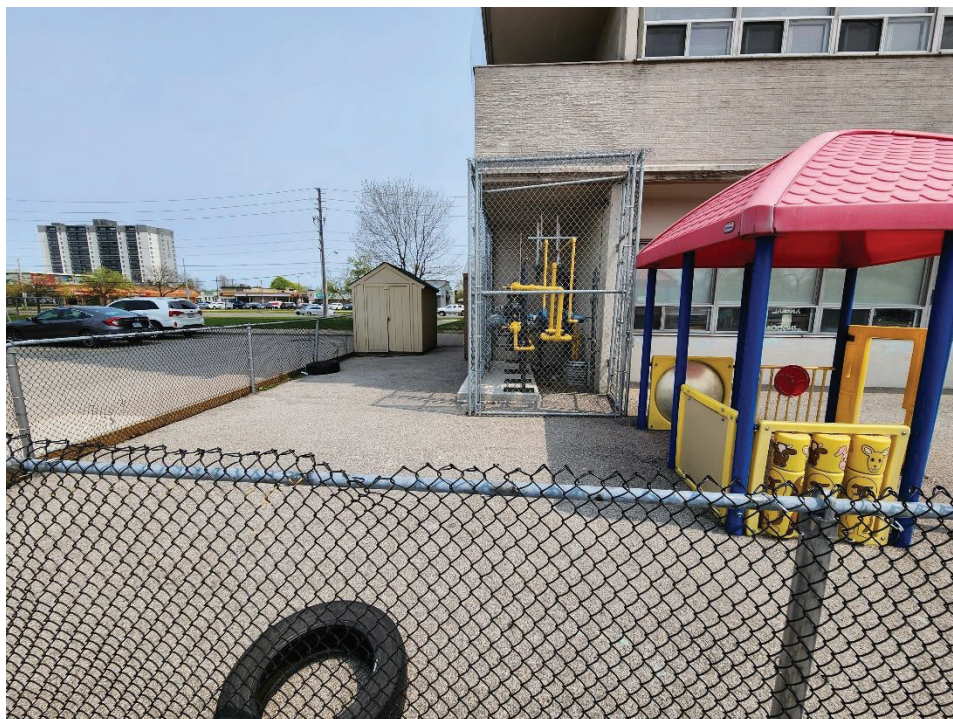
**Photograph 4:** View of former UST area along northwest corner of Site building

A 27,000L steel UST was located along the northwest corner of the Site building and was used for the storage of diesel heating fuel. Based on a review of the UST Decommissioning Report provided in the Phase I ESA (CCI, 2010), the UST and associated piping was decommissioned in 1997. Minor surface corrosion was observed on the tank and associated fill line. No soil contamination with respect to hydrocarbons and BTEX was identified at the time of the assessment. At the time of the Site reconnaissance, Keystone Environmental observed a levelometer and cut fill and vent pipes along the western wall of the boiler room.

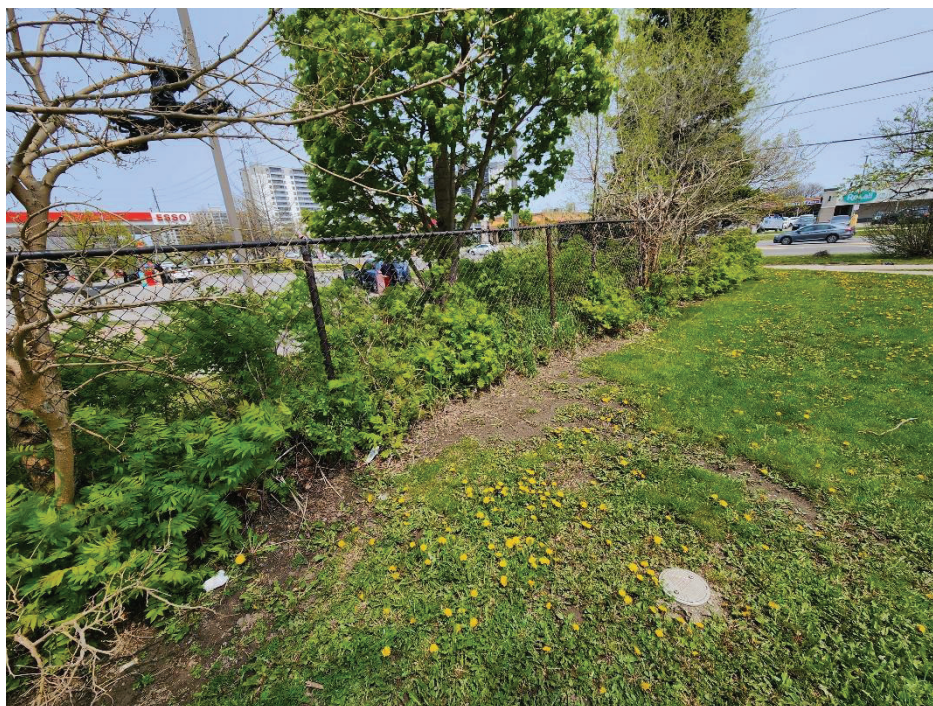
**Photograph 5:** View of north property boundary adjacent to Esso gas station

Evidence of four USTs was observed at the Esso gas station located north adjacent to the Site. However, no visible staining or evidence of surface spills / leaks was observed on the off-site property at the time of the Site reconnaissance.

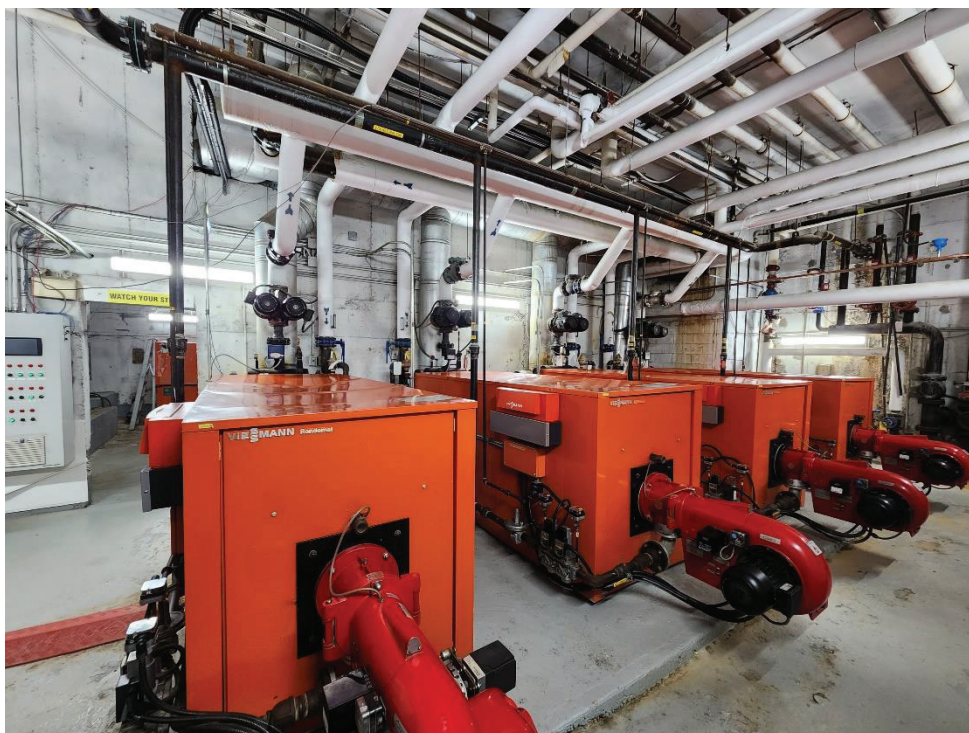
**Photograph 7:** View of natural gas-fired boilers in basement boiler room

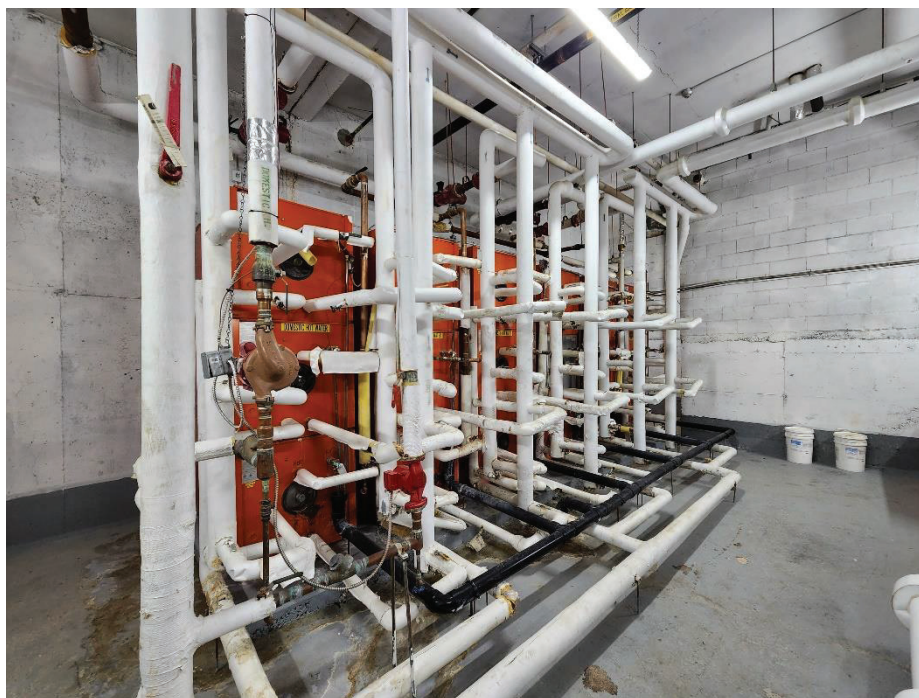
**Photograph 8:** View of hot water tanks in basement boiler room

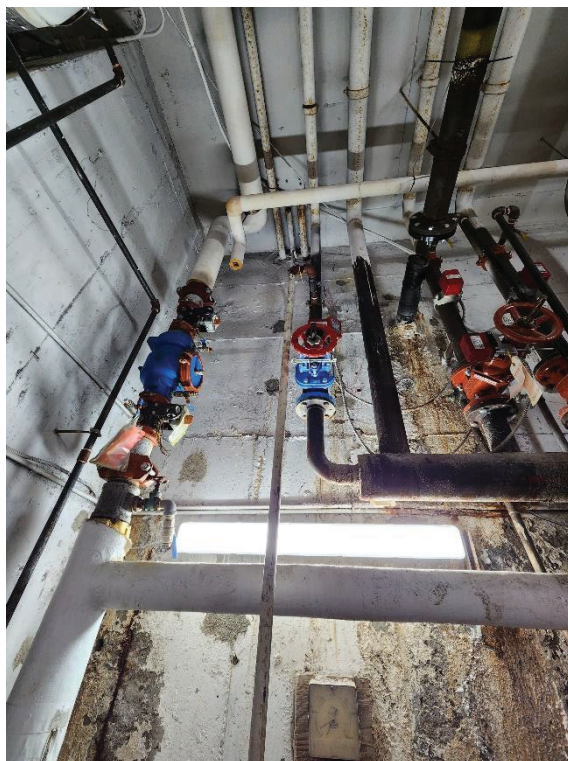
**Photograph 9:** View of levelometer and cut fill and vent pipes in basement boiler room

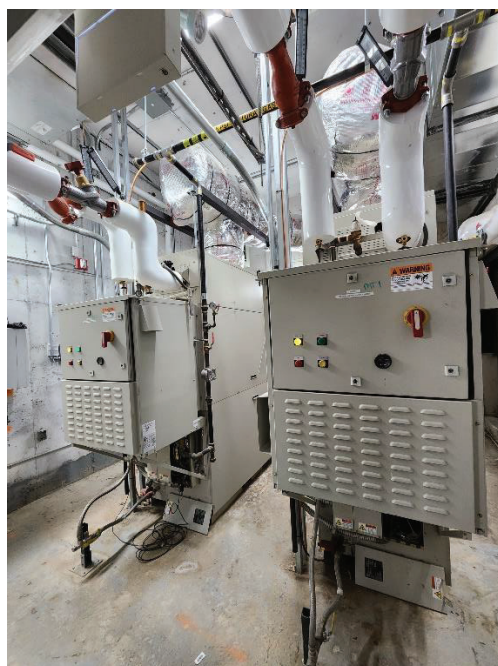
**Photograph 10:** Natural gas-fired generators in the basement generator room

- The Site was first developed with the current day Site building in 1967. Further, CAPREIT has owned the property since 1997.
- Two natural gas-fired generators are present in the basement generator room. No ASTs and / or USTs are present on the Site.
- No issues with odours or sheens from the sump pits located in the basement boiler room.
- Chemicals stored and used on Site are generally limited to small shelf-size commercial grade cleaners, used for general maintenance and cleaning of the Site Building.
- No issues of mould or water damage have recently been reported by any of the tenants or identified by the Site Representative.

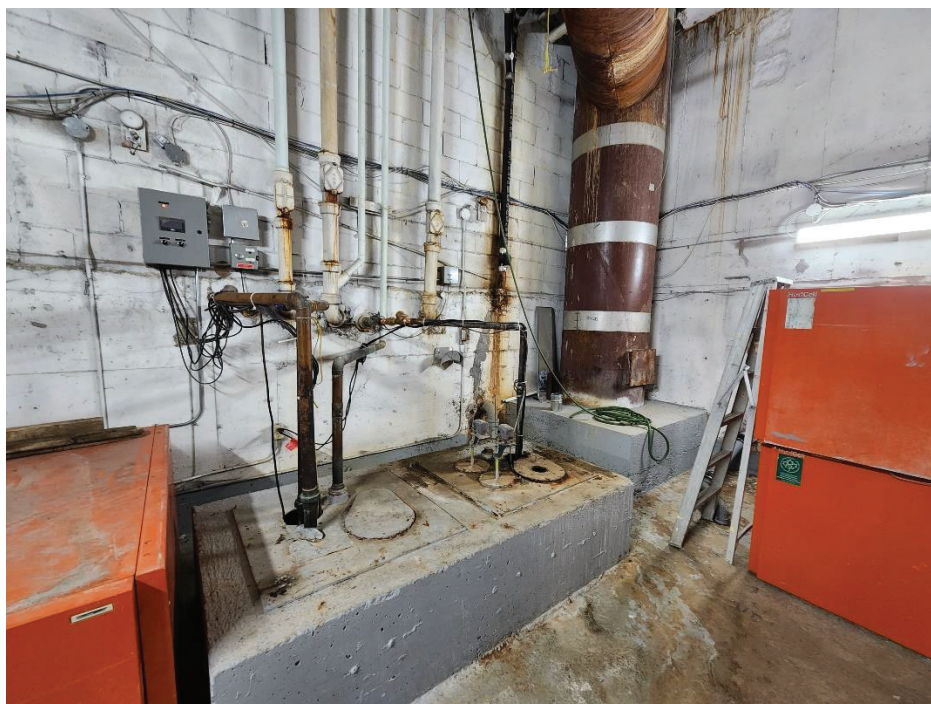
**Photograph 11:** Sumps in basement boiler room

Details & Operations	Description
<b>Interior: Drains, Pits and Sumps</b>	Two sump pits were identified within the basement boiler room. No visual or olfactory evidence of contamination was identified within either of the sump pits.  Drains were observed throughout the basement and garage, as well as common areas including the maintenance room and laundry areas.
<b>Exterior: Catchment Basins, Pits and Lagoons</b>	No pits or lagoons were observed at the Site during the Site reconnaissance, however, storm water catchment basins were observed along the hardscaped asphalt surfaces along Markham Road.
<b>Sewage and Stormwater Works</b>	Sewage transmission at the Site is inferred to be limited to storm water and domestic sewage waste.
<b>Watercourses, Ditches or Standing Water</b>	No watercourses, ditches or standing water were observed at the Site during the Site reconnaissance.

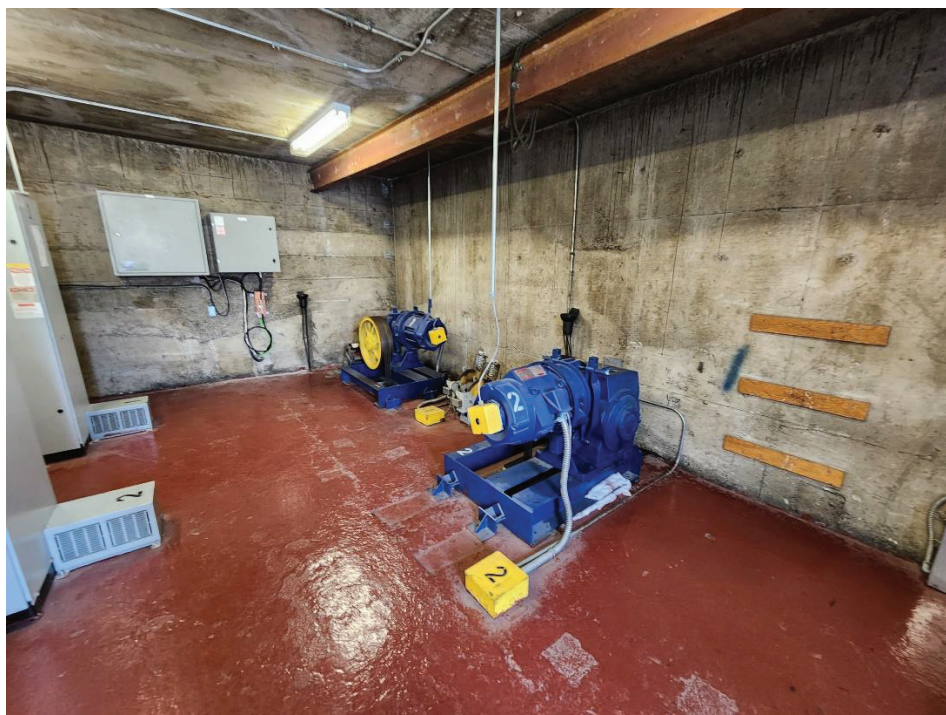
**Photograph 12:** Cable elevator equipment in rooftop elevator room

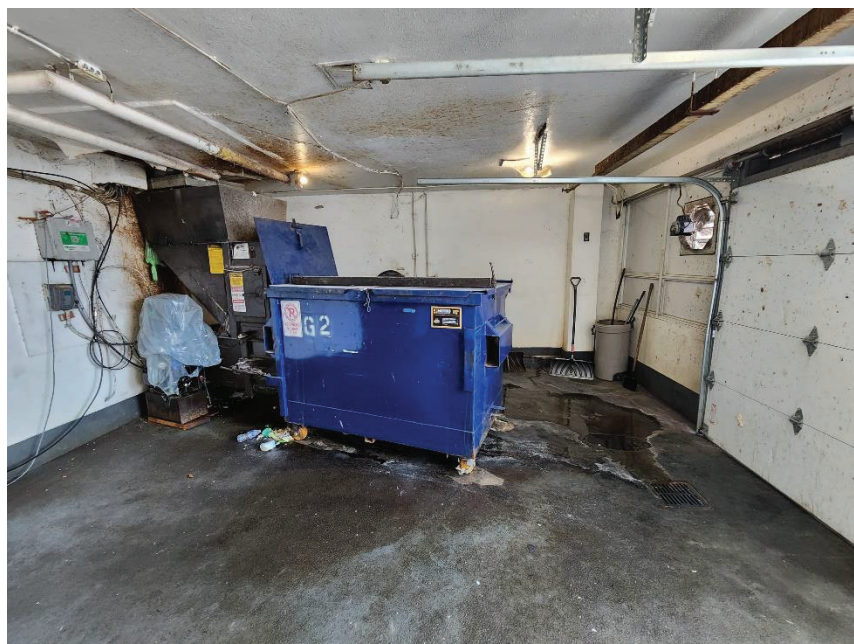
**Photograph 13:** Hydraulic garbage compactor in ground floor maintenance area

Items	Observations and Details
<b>Hydraulic Systems</b>	One hydraulic compactor was observed within the ground floor maintenance area, in the vicinity of the waste collection bins located along the western side of the Site building. The three elevators are comprised of an electric (cable) system.
<b>Railway Lines</b>	Railway lines were not observed on the Site or on the surrounding properties.
<b>Air Emissions</b>	No major sources of air emissions which could contribute to adverse environmental effects were identified at the Site or on the surrounding properties.
